PHOTOGRAPHIC SUPPLEMENT TO TERMITE INSPECTION REPORTS

By
C. E. Eaton and Donald DeLeon
Berkeley, California
August 21, 1941

The following photographs, taken at the request of C. B. Eaton, Forest Insect Laboratory, Berkeley, Calif., by Lt. A. H. Trumbull, Office of the Constructing Quartermaster, Fort Mason, Calif., show actual construction features of temporary mobilization buildings erected at Army posts in San Francisco and vicinity.

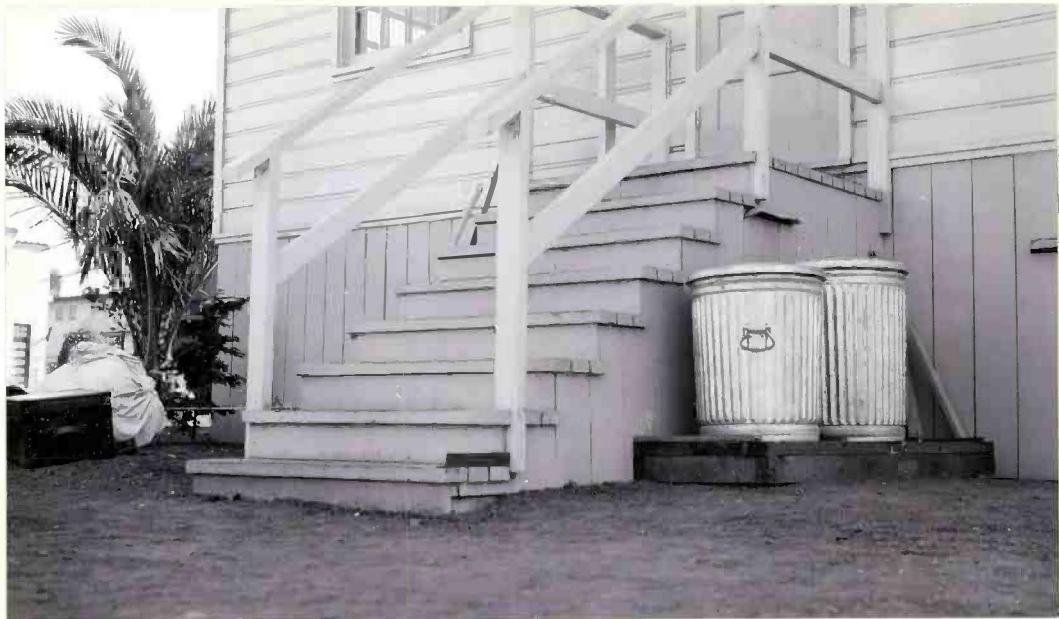
Figure 1. The wooden porch and steps provide direct ground to building contact by means of which termites can infest the building without being seen. The value of shields is completely negated by this type of construction. Porches and steps should be built on concrete footings so that the wood is clear of the ground by at least 6 inches.

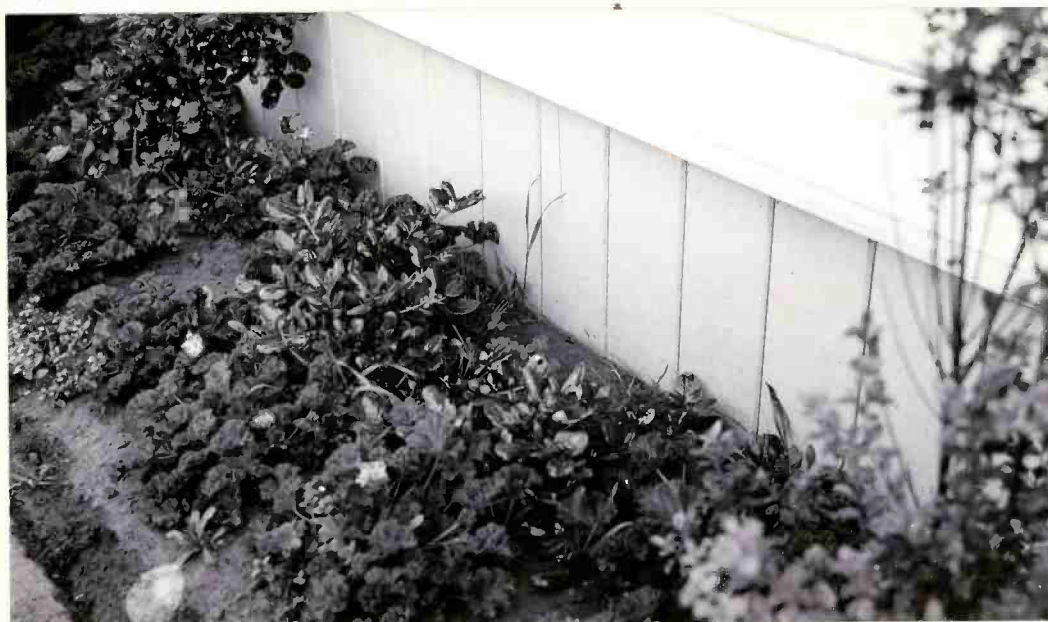
Figure 3. Landscape work performed after completion of this building resulted in soil being brought up over the bottom of the skirting. This condition should be corrected by cutting off the bottom of the skirting so that it clears the ground level by at least 6 inches.

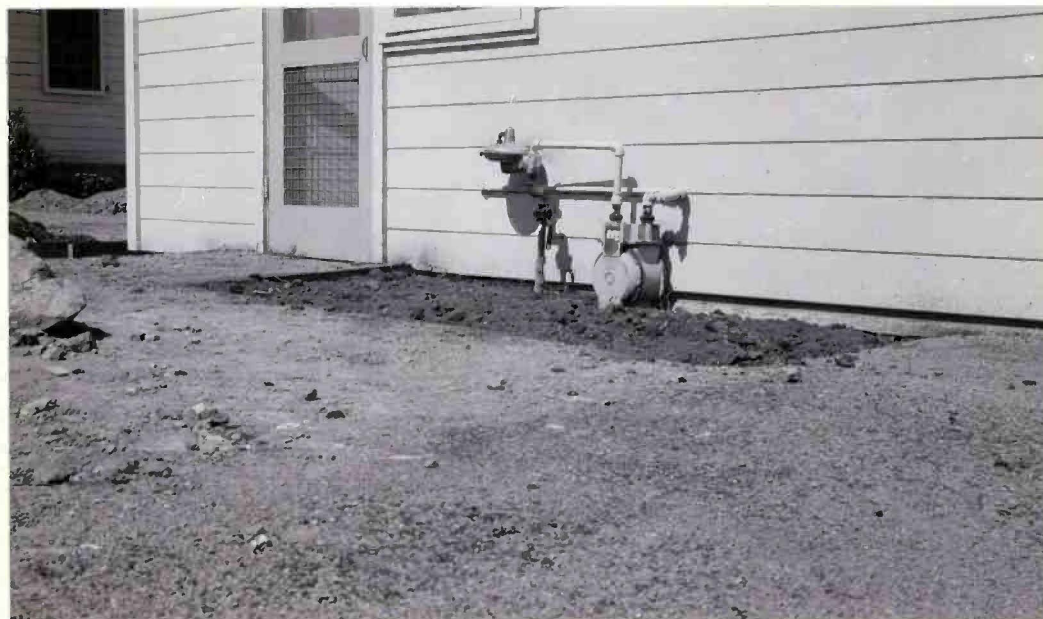
Figure 4. Soil around this building partially covers the termite shield and is in contact with the bottom of the siding, making possible concealed entrance of termites to the building. The final grade should be lowered so that the siding is clear of the ground by at least 6 inches. Shields covered in this manner are useless in preventing termites from entering a building.

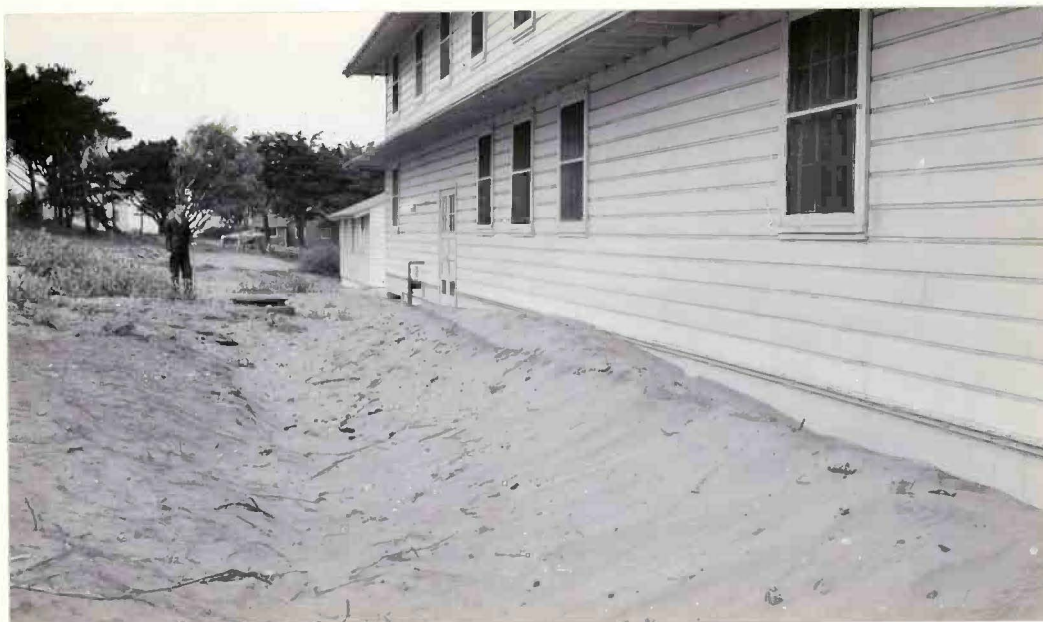
Figure 5. Loose soil has blown up against this building covering termite shields, skirting, and part of siding and cutting off air circulation beneath the building. To prevent hidden termite entrance to this building, the grade level should be lowered to 6 inches below the bottom of the siding and should be kept at this level.

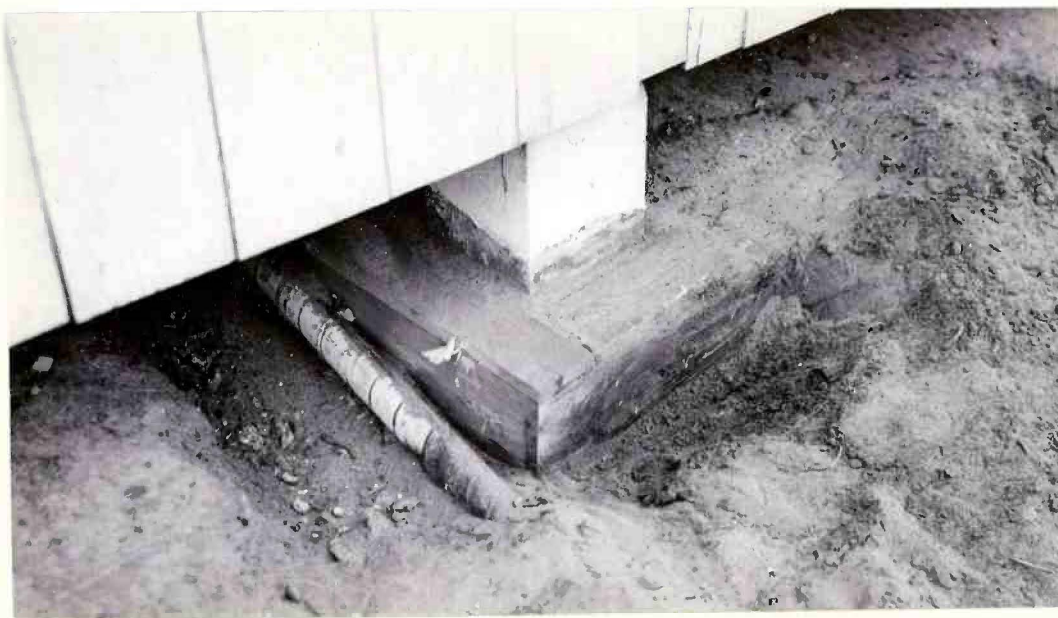
Figure 6. Form boards left in the ground around concrete footings are a potential source of termite infestation. The form boards around this pier were infested within three months after construction was completed. Grade stakes, shavings, and wood debris should be removed and burned rather than be left in the soil.

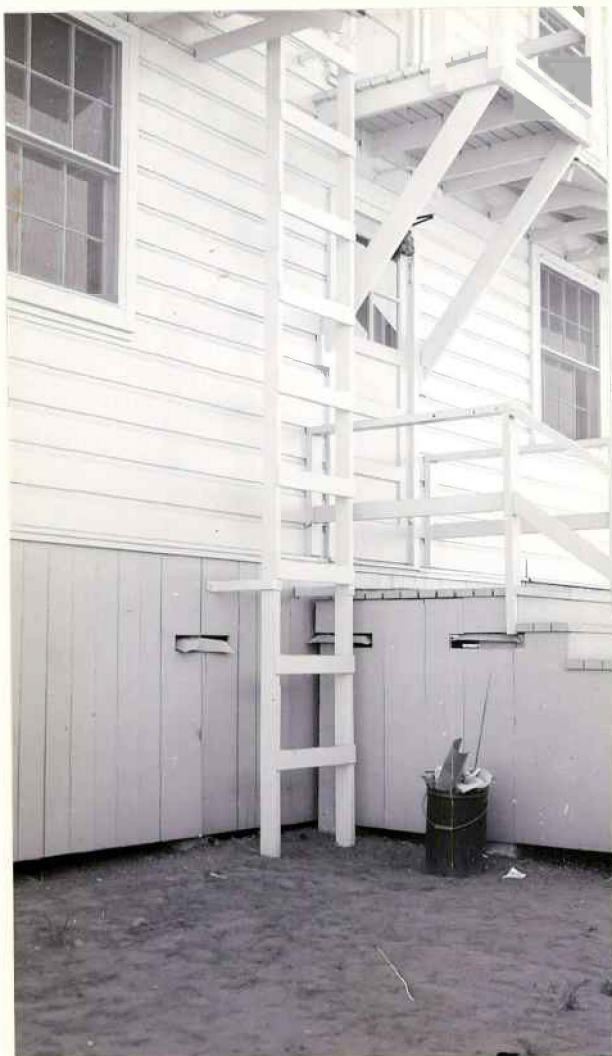
Figure 8. Fire ladder provides a direct ground to building contact by means of which termites can infest building without being seen. This should be corrected either by setting the ladder on a concrete footing 6 inches high, or else by cutting off the bottom of the ladder so that it clears the ground by an equal distance.

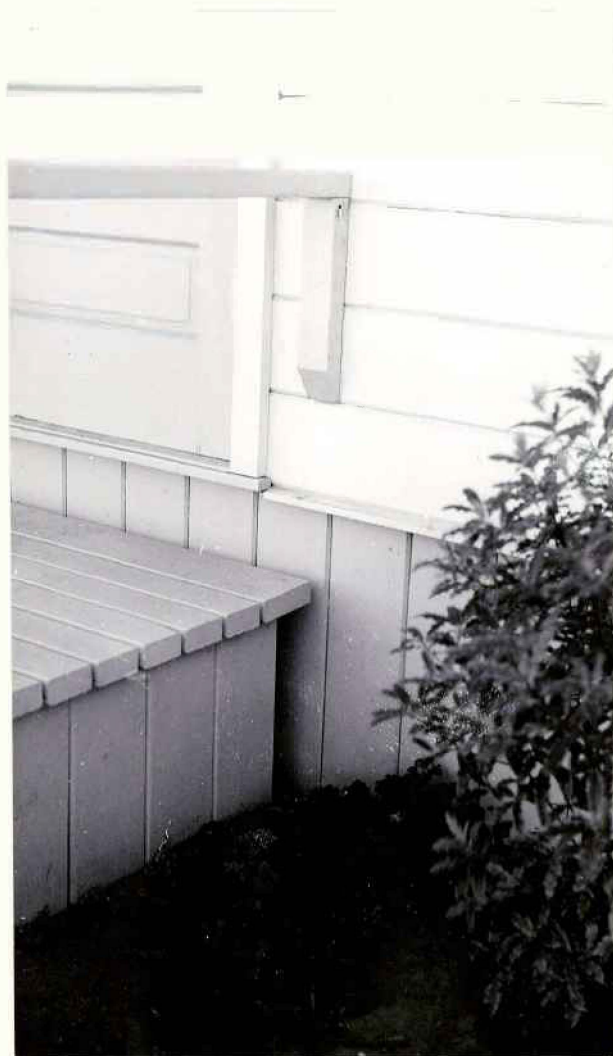
Figure 9. Setting the entrance platform away from the building is one means of preventing hidden entrance of termites to the building through wood. In the case shown above, the effectiveness of this measure is partially nullified by the handrail, which is tied in to the side of the building.
